United States Department of State  
and the Broadcasting Board of Governors  
*Office of Inspector General*

### Limited-Scope Review of the Design and Construction of a Recreation Center at Embassy Dushanbe, Tajikistan

**Report Number MERO-I-11-04, March 2011**

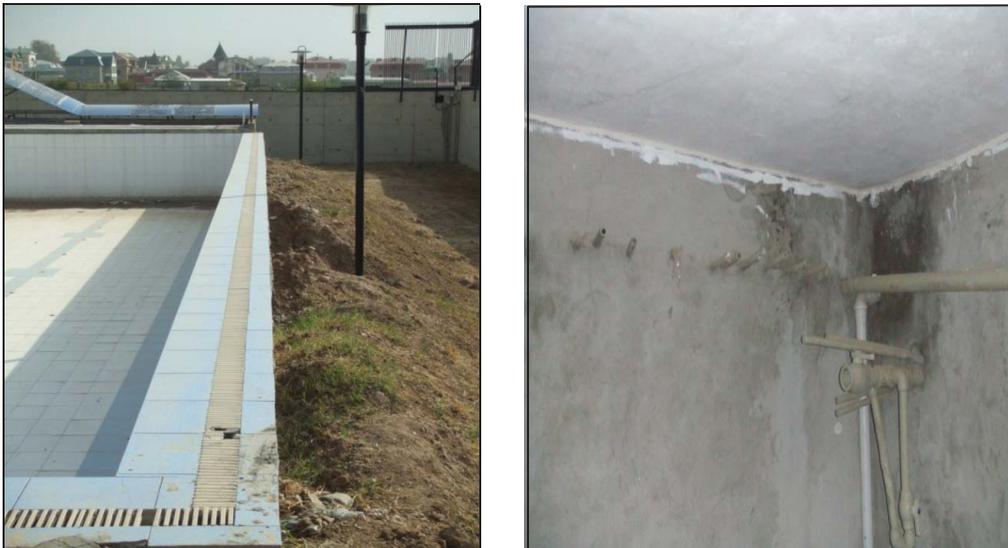
OIG confirmed through physical observation at Embassy Dushanbe and analysis that the constructed facilities in their current condition do not comply with International Building Code (IBC) specifications, OBO's Standard Embassy Design (SED), Americans with Disabilities Act (ADA) accessibility guidelines, and other internationally accepted mechanical, plumbing, and electrical codes. This finding corresponds with the results of Swanke Hayden Connell Architect's evaluation of the Dushanbe recreation center, which showed that the construction was substantially incomplete and the recreation center was not constructed in accordance with required codes and guidelines. Swanke Hayden Connell Architects reported that the site paving, site retaining walls, the pools and pool deck areas, electrical system, and pool filtration and heating systems were not completed, which resulted in an unsafe and largely unusable facility. In addition, Swanke Hayden Connell Architects determined that the site design of the pools and deck areas was not compliant with the IBC. As a result, OBO concluded that all swimming pool facilities must be demolished, redesigned, and reconstructed, except for the tennis court which was repairable. OBO estimated tear down and reconstruction costs to be approximately \$1.5 million. The initial project cost was \$318,913. As of October 2010, OBO had issued a modification to the existing task order for Swanke Hayden Connell Architects to begin redesigning the recreation center. The actual reconstruction contract will be re-competed, and rebuilding, according to OBO's plan, will not commence until late 2011. Instead of RPSO, the Office of Acquisition Management (AQM) in the Bureau of Administration will administer the redesign and reconstruction contract; an OBO employee will act as the COR. Table 2 outlines the deficiencies in design and construction. Figure 1 shows the condition of the swimming pool and the pool equipment room at the time of OIG's visit to Embassy Dushanbe.

**Figure 1: Condition of the recreational facilities at Embassy Dushanbe:** The photo on the left shows incomplete and poor quality construction of the swimming pool. The photo on the right shows pipes protruding from the wall of the pool equipment room.
